## ResInnova LABORATORIES

## Final Report

### Purpose

Figure 2: UV Reduction of *C diff* Spore Recovery on Vanity/Sink Surfaces

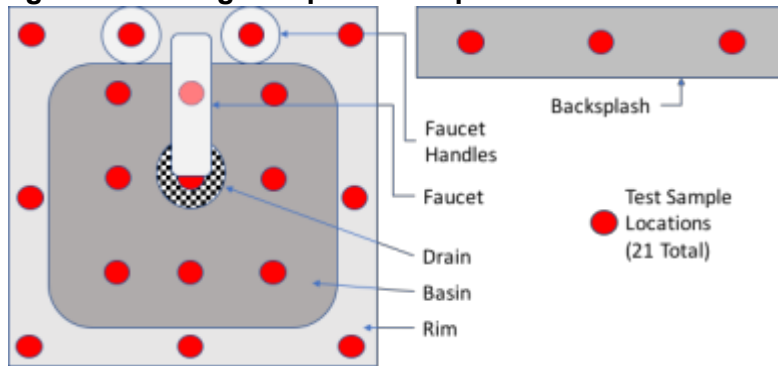
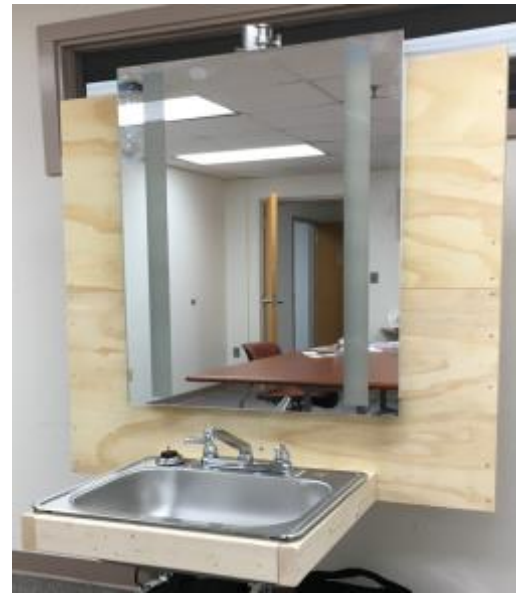
**Figure 1: Testing Setup and Sample Placement**

- Samples were placed on several locations on a vanity/sink. See Figure 1 for placement and overall setup.

- Prototype 1 with a UV LED strip mounted parallel to the bottom of the mirror and recessed from the bottom of the mirror. A UV LED strip was also mounted inside the mirror.
- Prototype 2 with a UV LED strip mounted flush with the bottom of the mirror at an approximate 45° angle facing away from the mirror.

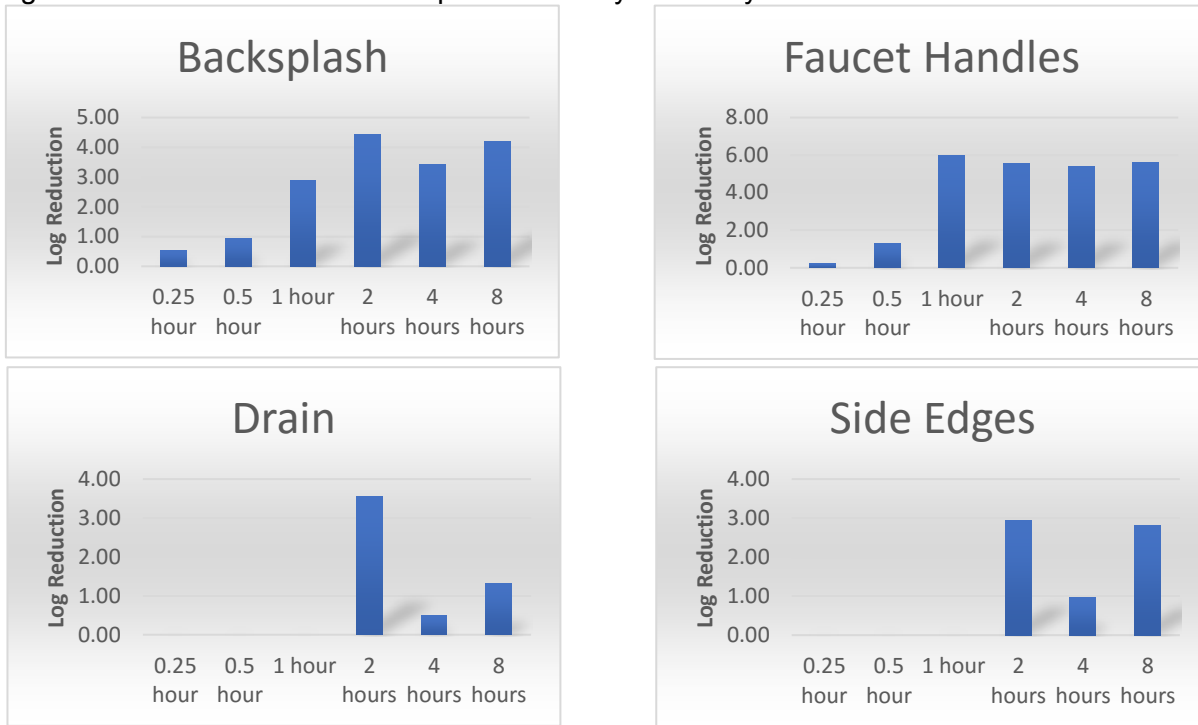
We tested the bacteria killing ability of two MunnWorks UV-emitting mirror prototypes. The first prototype we received demonstrated robust reduction of spore viability on backsplash surfaces. The compiled results after testing of both prototypes are presented in Figure 2. After one hour exposure, reductions approached 3 logs (99.9%) and surpassed 4 logs (99.99%) after 2 hours (Figure 2, Backsplash). This first prototype, however, had several deficiencies as it failed to reduced spore viability on faucet handles and on surfaces greater than 7 inches from the light source. It was decided by MunnWorks to create a new prototype based on these results and we discontinued testing on the first prototype.

The second prototype increased the reach of the UV achieving a 2.94 log reduction of *C diff* spores on the sink side edges (the rim of the sink approximately 14 inches away from the light source) after 2 hours. The second prototype also improved UV exposure to faucet handles achieving greater than 4 log spore reductions were seen after just 1 hour and 3.5 log reductions were seen at the sink drain after 2 hours of exposure. This prototype also showed a 3.56 log reduction in spores at the sink drain (no reductions were seen in the first prototype). No reductions were seen in the sink at points immediately adjacent to the sink wall proximal to the UV source or on the distal sink edge (data not shown). This prototype also failed to deliver adequate UV to the backsplash (data not shown).

There were several anomalous results during testing. Several data points seen in Figures 2 and 3 show that longer UV exposures do not improve bacterial reduction outcomes. This phenomenon is particularly true at the drain and sink edges for all three organisms. It should be noted that a major failing of all UV technologies is shadowing. For our simulated sink testing (Figure 1) we used a rotating faucet. It is possible that, for the drain test points, the faucet may have been moved relative to the position of our test sample resulting in a shadow effect that reduced the UV exposure at that test point. The sink we used for testing has beveled edges. Any shifting in the position of the sink edge test samples may have resulted in a dramatic effect on the UV exposure to the sample (another example of shadowing). Shadowing, however, does dramatically limit the utility of this technology on surfaces immediately adjacent to the sink wall proximal to the UV source and to surfaces greater than 22 inches from the UV source (data not shown). Regardless, there is ample evidence that significant bacterial reductions are achieved at critical areas such as the backsplash, faucet handles, drain and sink edges.

- The first prototype demonstrated dramatic *C diff* spore reductions on backsplash samples:
  - Backsplash
    - > 4 logs after 2 hour exposure.
- The second prototype demonstrated dramatic reductions with *C diff* spores, *E coli*, and MRSA on several critical sink areas:

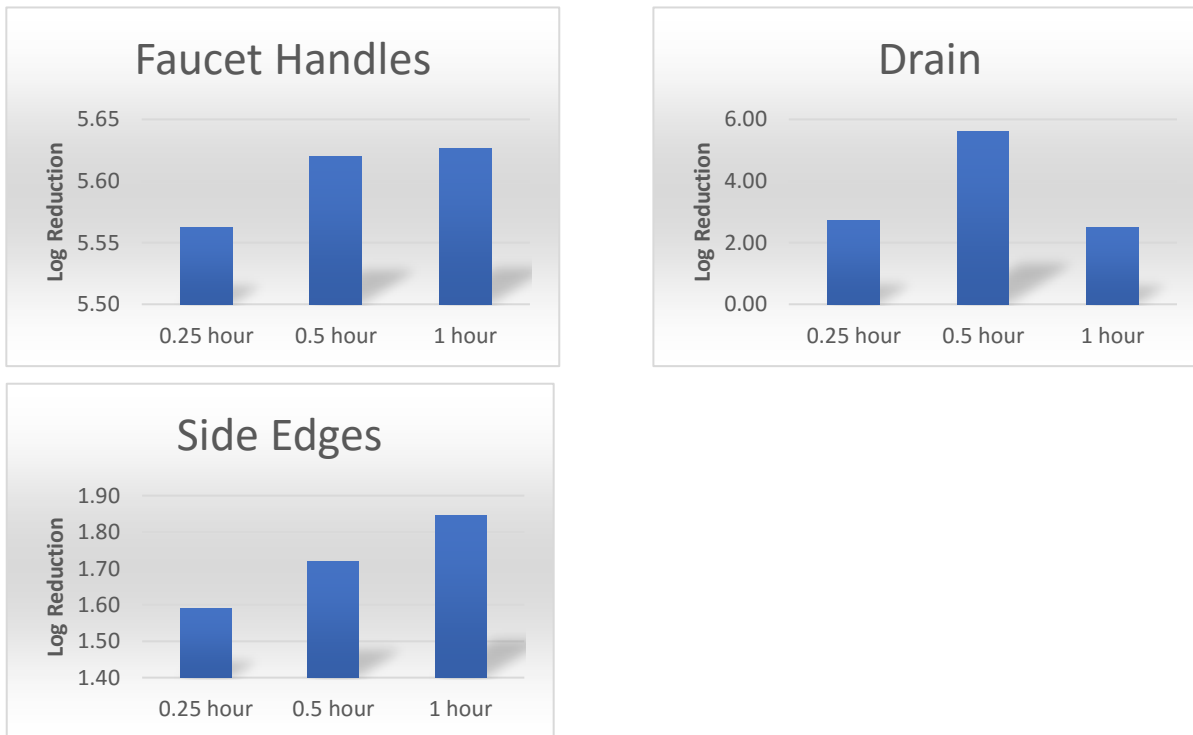
Figure 3: UV Reduction of *E coli* Recovery on Vanity/Sink Surfaces

We were also able to test the ability of the second prototype to kill both *E coli* and MRSA. Testing against *E coli* demonstrated greater than 4 log reductions for both faucet handles and the drain after just 30 min (Figure 3). Regardless of how long we exposed the sinks to UV, the mirror failed to produce greater than a 1.9 log reduction on the edges of the sink (approximately 14 inches from the UV source). For the faucet handles and sink drain, MRSA results were similar to *E coli*, with greater than 4 log reductions seen within an hour of exposure to UV (Figure 4). On the sink side edges, however, MRSA demonstrated a greater than 4 log reduction after an hour of UV exposure. For neither *E coli* or MRSA were bacterial reductions seen in the sink at points immediately adjacent to the sink wall proximal to the UV source or on the distal sink edge (data not shown).

- Faucet Handles
    - *C diff* spores: > 4 logs after 1 hour exposure;
    - *E coli*: > 4 logs after 30 minute exposure;
    - MRSA: > 4 logs after 30 minute exposure.

- Drain
    - *C diff* spores: > 3 logs after 2 hour exposure;
    - *E coli*: > 4 logs after 30 minute exposure;
    - MRSA: > 4 logs after 30 minute exposure.
